Report No.: XMDN221219-62201E-SF

Measurement and Test Report

Test model: S539

This Report Concerns:	**Equipment Type:**
☒ Original Report	Door Phone

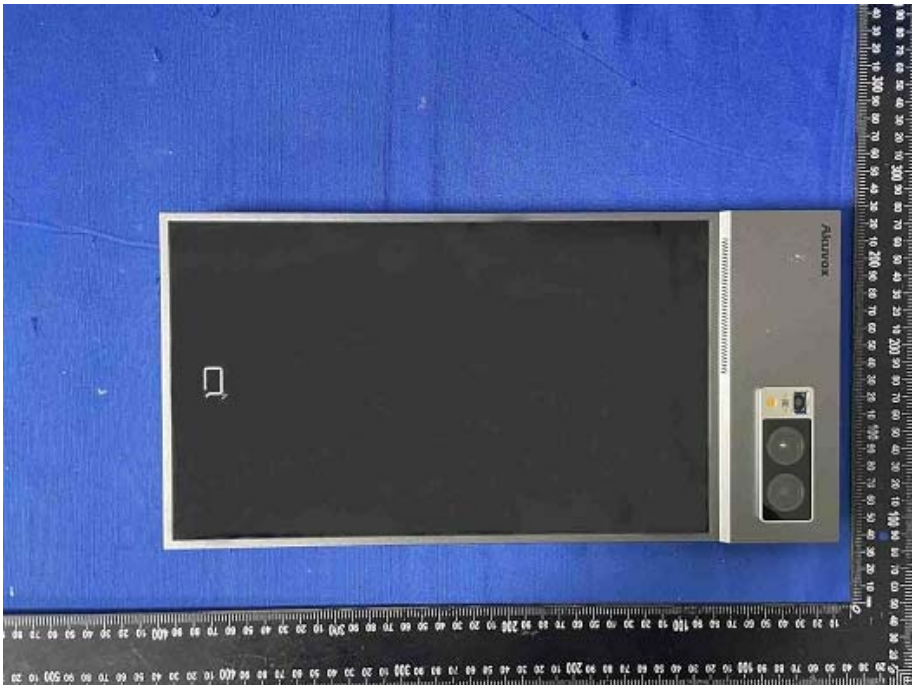
Sample No.: 1VYF	5J (IK08)
Camera area	P
Screen area	P
Bottom area	P
Side area	P

Result: The IK code of the sample comply with level-IK08.
