IEC 62262:2002+AMD1:2021

Measurement and Test Report

AKUVOX (XIAMEN) NETWORKS CO., LTD.

Test model: S538

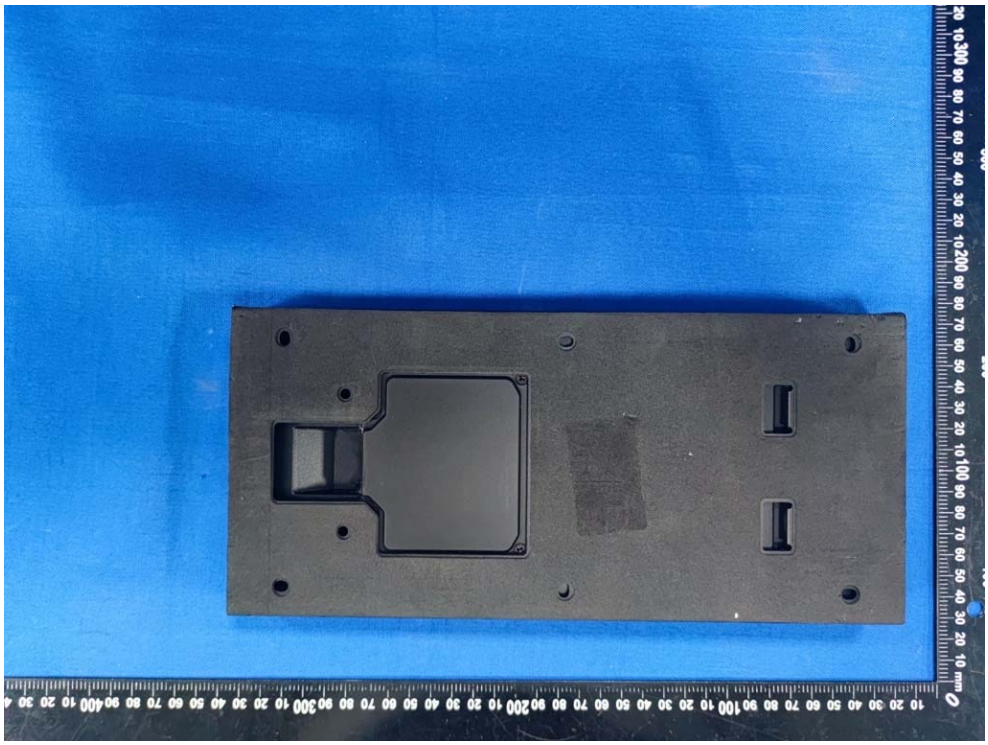
Sample No.:	5J (IK08)
Top surface	P
Side surface	P
Bottom surface	P

Result:
(x) After the IK08 drop shock test, no damaged.
(x)The IK code of the sample complies with level-IK08.
